Visual Pollution of Commercial Street Sidewalks: A Case Study of Design Standards in Al-Hilla City, Iraq

Case Study the Sidewalks of the Commercial Street in AL-Hilla City (Street 40):

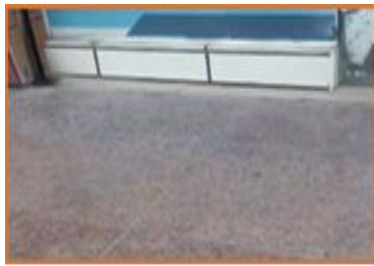
Fig 4.shows the variation of the finishing materials in some areas of the sidewalk, as well as the asymmetry in the sidewalk level. Source (Researcher)

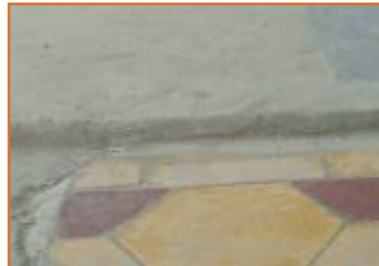
Fig (5)shows the variation of the finishing materials in some areas of the sidewalk, as well as the asymmetry in the sidewalk level. Source (Researcher)

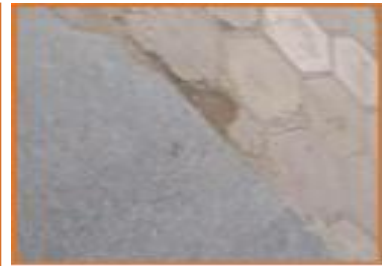
Fig 6. shows a variation of the sidewalk finishing materials. Source (Researcher)

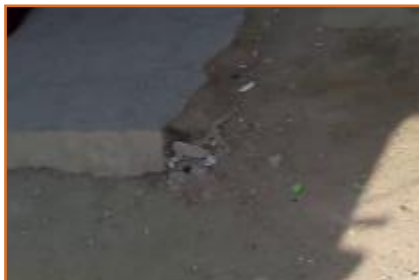
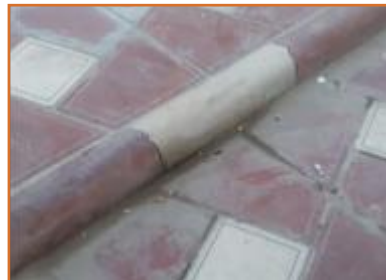
Fig (8) Source Researcher))

Fig(7) and Fig(8) show a discrepancy in the sidewalk level. Source (Researcher)

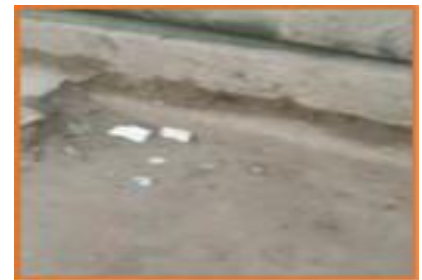
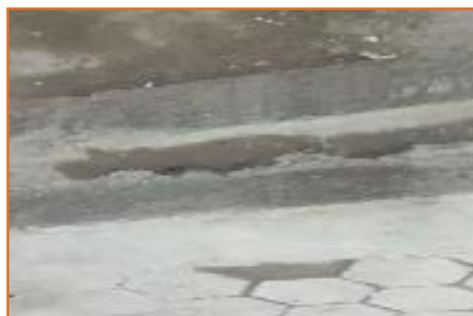
Fig(9). Source (Researcher)

(9) Fig(9) and Fig(10) show the inconsistency of the height of the sidewalk level with the street. Source (Researcher)
